To: Adam Overend, AScT
Senior Engineering Technologist
District of Central Saanich, Engineering
Department

Date: July 20, 2023

Reference: Brentwood Bay Sanitary Sewer Upgrade Project – Bald Eagle Nest

Wallace Drive Sanitation Tree Protection Plan

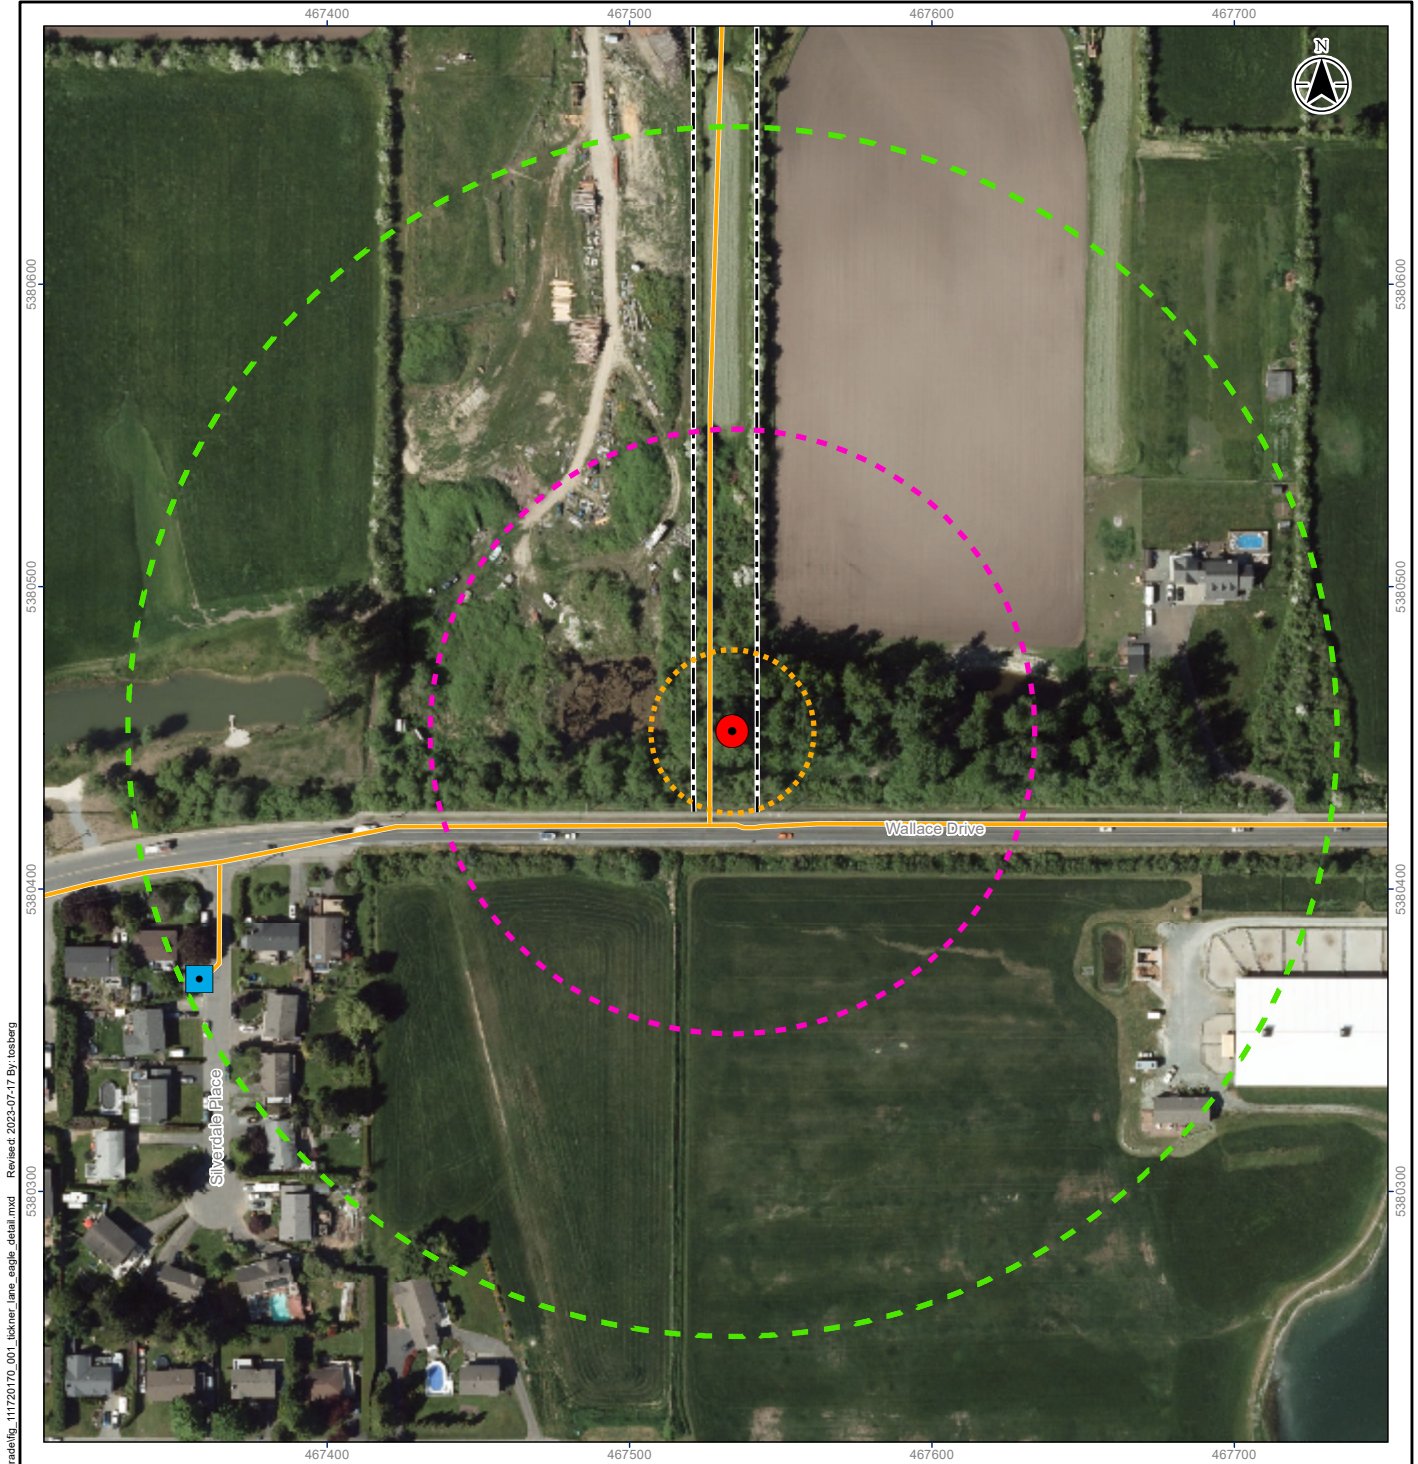
Figure No. **1**
 Title: **Location of Bald Eagle Nest Tree within Tickner Road Allowance**

A bald eagle (*Haliaeetus leucocephalus*) nest is located within the Tickner Road road allowance (UTM 10U 5380452.58 northing, 467534.88 easting) approximately 10 m from the sanitary sewer line and 25 m from Wallace Drive (Attachment A). This nest was first identified in 2019 and was used for nesting in 2019, 2021, and 2022 (WiTS 2023). Bald eagles are protected under Section 34 of the provincial *Wildlife Act* which prohibits the injury, molestation, destruction, or possession of a bald eagle individual, egg, or nest. Bald eagle nests are also protected year-round, whether active or not, and a permit from the Province is required if a nest needs to be removed or destroyed. If an activity or development will “molest, injure or destroy” a nest site (i.e., the nest or nest tree), protective buffers may need to be established to reduce disturbance to the nest, although the degree of protection required is not specified by the Act. While the provincial government retains jurisdiction over raptors in British Columbia, the Central Saanich municipal government is responsible for the protection of trees, including nest trees, in Central Saanich, through the Tree Management Bylaw (Bylaw No. 2065).

- Based on the recommendations of the Certified Arborist, clearing and construction activities should be avoided within the CRZ, a 27.0 m buffer around the tree to protect the integrity of the tree root system (Attachment A). The sanitary sewer line will be located within the road allowance as far from the nest tree as is technically feasible and the construction footprint will be reduced to the extent practical within the CRZ.

- Best management practices for bald eagle nests in rural areas recommend a 200 m 'quiet zone' buffer around the nest tree when the nest is active to reduce disturbance to the adults and young (BC MFLNRO 2013) (Attachment A).

- Best management practices for bald eagle nests in rural areas recommend a year-round 100 m buffer around the nest tree (Attachment A) to maintain habitat (BC MFLNRO 2013). Within the 100 m habitat protection buffer (BC MFLNRO 2013) the width of the construction footprint should be reduced to the extent practical. Vegetation outside of the construction footprint but within the 100 m habitat protection buffer should be retained (Attachment A).

- Vegetation clearing and construction activities related to the Wallace Drive and Tickner Road sanitary sewer line installation will be avoided within the 200 m quiet zone buffer (see Attachment A during the active period).

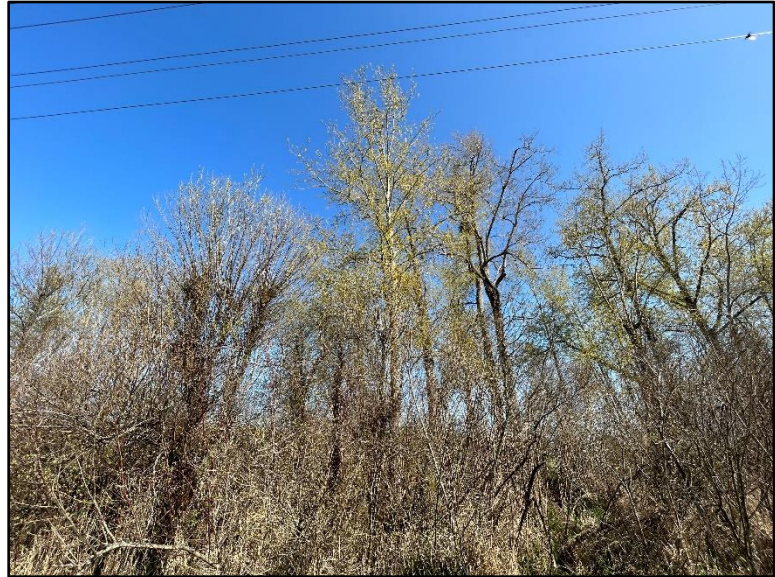
Photo 1. View of the subject trees from the sidewalk at the north side of Wallace Drive (04/28/2023)

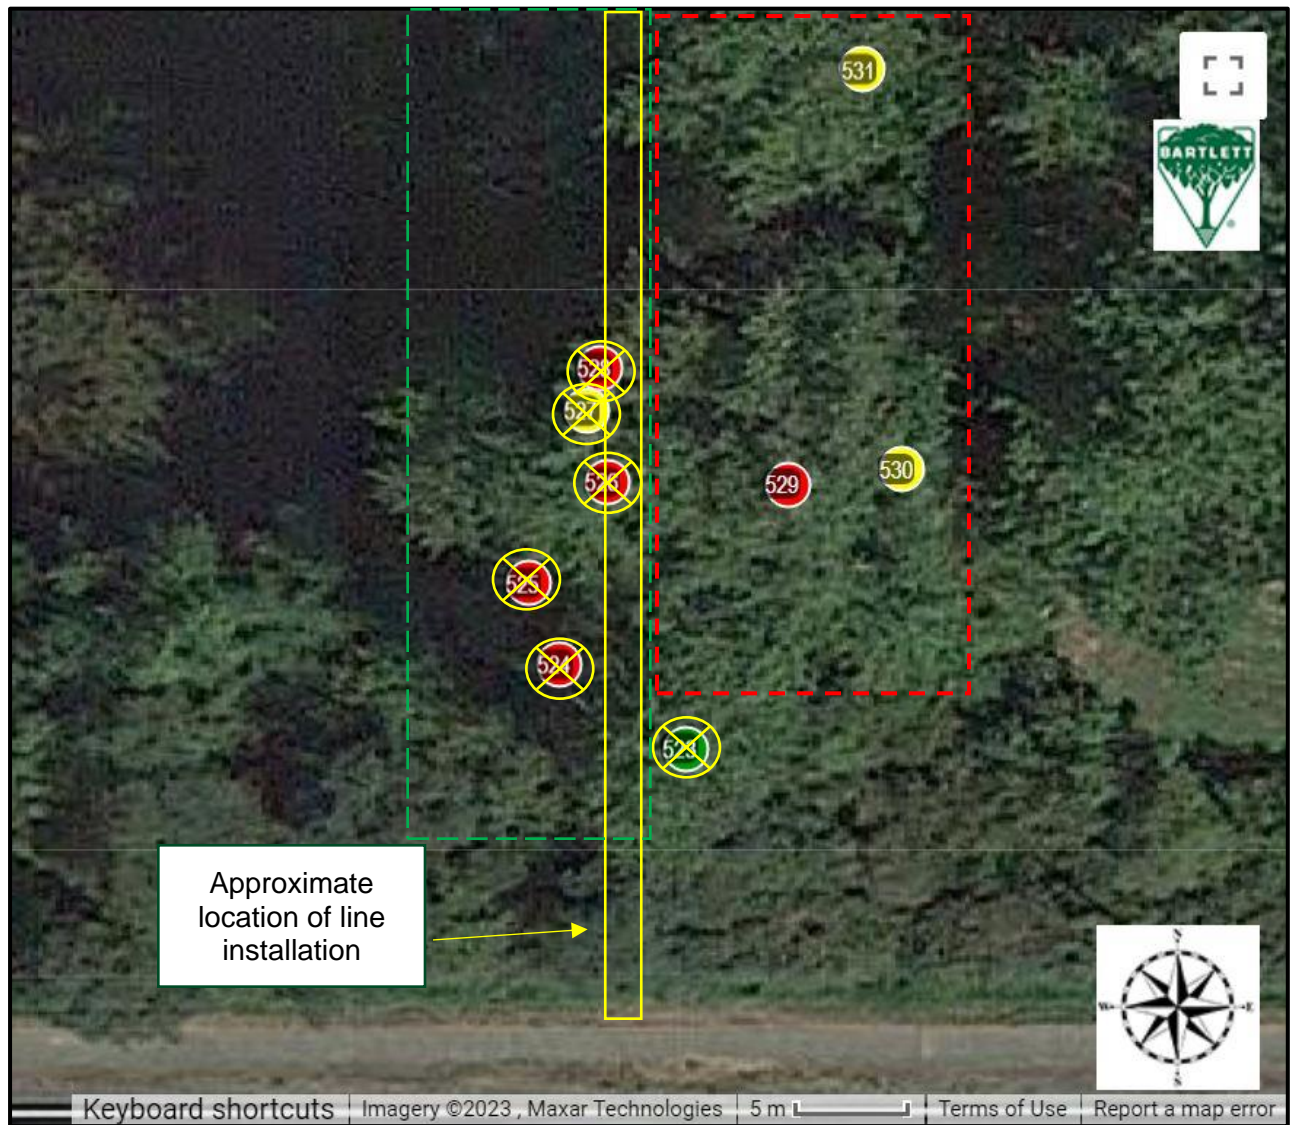
Appendix I – Site Map

The proposed project will require the removal of the following trees:

- Three Balsam poplar (*Populus balsamifera*) #523, #526, #527
- Two crabapple (*Malus fusca*) #524 and #528
- One Babylon willow (*Salix babylonica*) #525

The large multi-stemmed Balsam poplar #530 tree has an active Bald Eagle nest in the upper canopy. As such, all work must be planned around the retention of this tree and timed when the nest is no longer active. The over-mature tree has an estimated 180cm DBH, the stem was larger than my diametric tape could measure. The trees canopy radius is widespread (~15m) and the work is likely to infringe upon the trees CRZ due to the limit area. The species of tree have a moderate – good construction tolerance. To my understanding the trench required for the sanitary line installation will be approximately 1m wide and at least 1m below grade. The further the trench is to the west of this tree, the less likely it is to encounter any significant structural roots from the tree.

Balsam poplar tree #529 is in poor structural condition. The estimated 112 cm DBH tree CRZ will not be entirely protected as the proposed trench excavation is approximately 5m from its base. Ideally, this tree could be retained to act as a wind dampening buffer for tree #530. However, it has large deadwood in the upper canopy and an overextended limb over the proposed work zone on the west side of its canopy. A retrenchment prune to remove the large deadwood and reduction of the overextended canopy is recommended prior to the work.

Other smaller understory trees and shrubs, not included within the inventory due to the diameters being less than 10cm, shall be removed as well. It is recommended that these trees be cut down with a chainsaw and not pulled with a machine when in proximity to any retained trees CRZ.

The mature balsam poplar #531 will also be retained and have tree protection fencing installed to protect as much of the trees CRZ as possible. Similar to the tree above the Project Arborist will oversee a preliminary excavation is to identify any significant roots outside the trees fencing. Roots encountered will be pruned to minimize the size of the wound to ensure their best chances of compartmentalization.
